USING NON-DESTRUCTIVE TESTS FOR EVALUATING FLYOVER FOOTBRIDGE: CASE STUDY

The current research paper aims to investigate the current flyover bridge condition, to present a justification for the Liverpool city council if the bridge could be still working after minor maintenance or they should start the demolishing work.

The Churchill Way flyover, Liverpool. This structure was completed and accessible to the public in 1969 as a part of the 2.4 million pound scheme ‘Mersey Tunnel relief scheme’. This concrete structure is a winner of the Concrete Society Award, awarded in 1971 for being “elegant and efficient” [11] as shown in Figure 1.

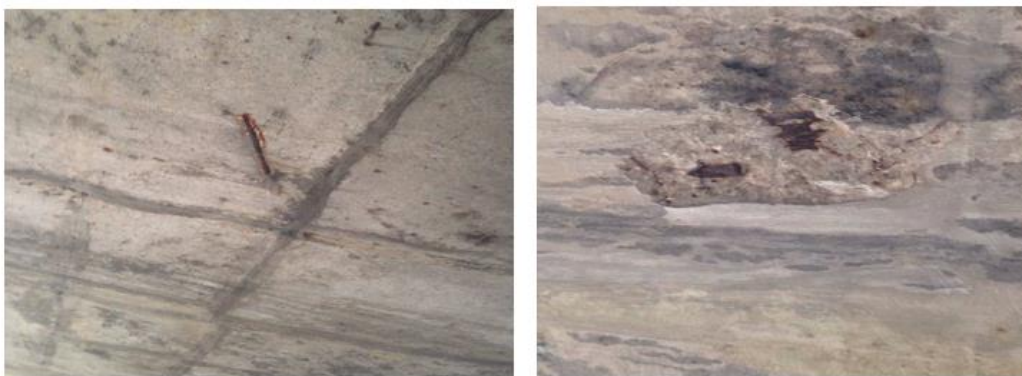
Figure 2: The underside of the Churchill Way flyover, rust coloured stain marks.

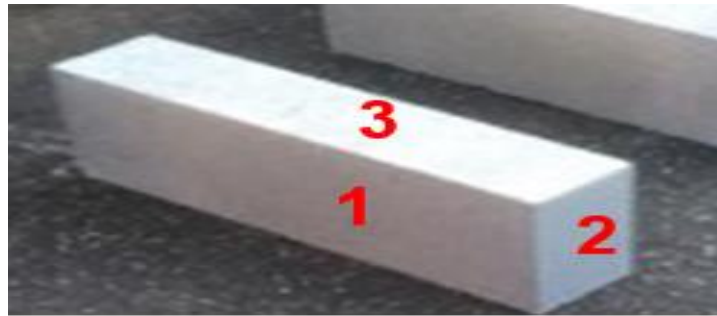
Figure 3: Block Faces Tested (410 x 210 x 95).

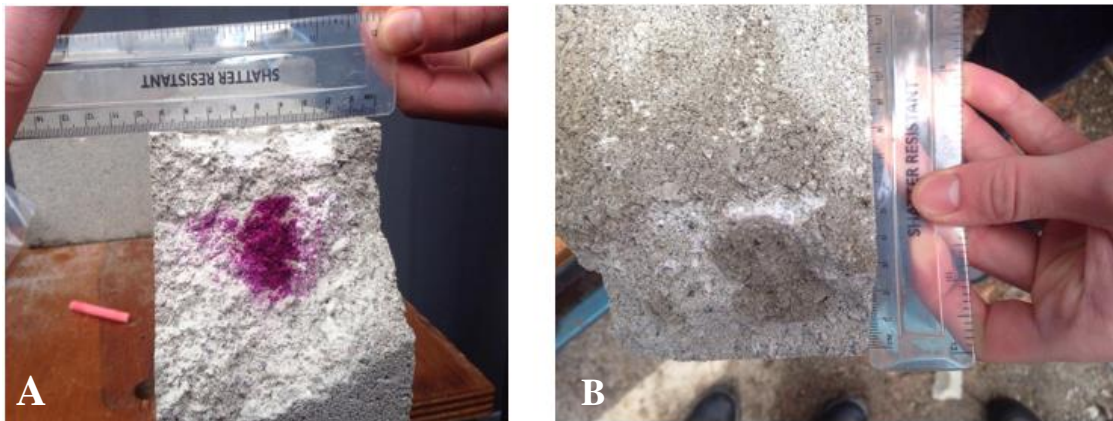
Figure 4: Depth of carbonation.

When compared with the other two sides, it seems to support the theory that it was sitting in a pile with a side (95mm) face down. Side 2 + 3 have considerably more de-passivation, carbonation present to a depth of about 40 mm. The carbonation rate is fast in a breezeblock as it has a lower density than most concrete, higher porosity and is made from Mersey silt, unlike some other concrete. If this had been in a building the likelihood that the carbonation front may have reached the reinforcement leading to the steel being vulnerable to chemical attack. The time may cause the structure to become structurally defective without the external warning signs as with other forms of degradation.

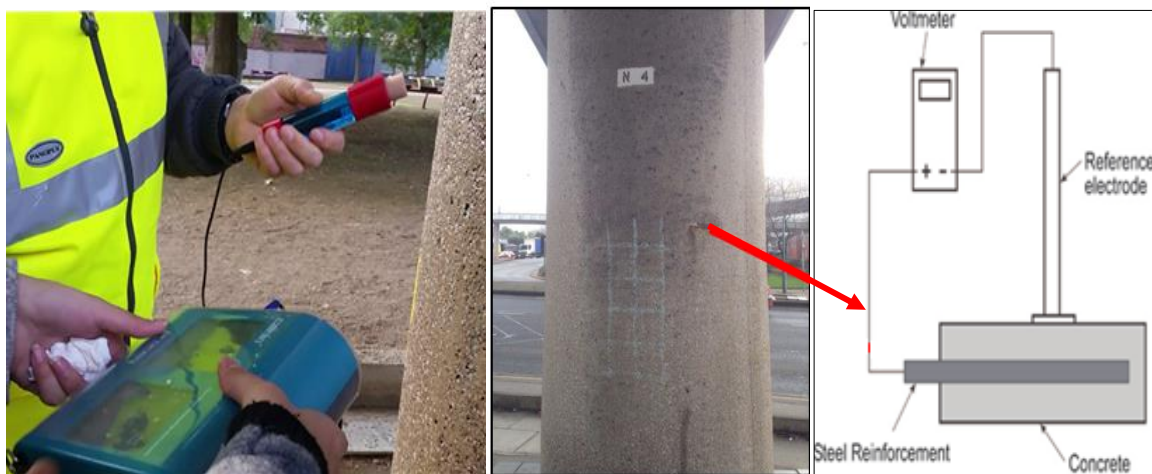
The Half Cell test is a way of predicting the corrosion that could take place using the way that steel reinforcement corrodes due to copper sulphate or CuSO4. A small amount of cover is removed, and the contact is made electrically, then the surface is wetted to create a completed circuit between the steel reinforcement and the reference electrode placed on the surface concrete as shown on Figure 5. The electrical activity of the steel reinforcement and the concrete leads them to be considered as one half of weak battery cell with the steel acting as one electrode and the concrete as the electrolyte [22].

Figure 5: Conducting Half-cell corrosion potential testing.

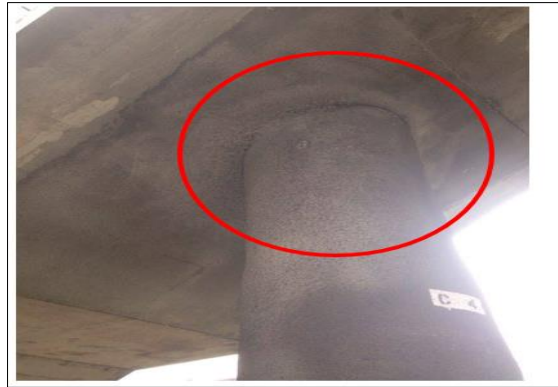
Furthermore, Figure 6 shows inconsistent marks on the joint between the column and the underside of the flyover. It suggests there has been a sprayed concrete repair in the past. This would affect the results the Schmitt hammer produce, as the concrete would be younger and not indicative of the concrete internally; the concrete that is doing the majority of the load-bearing for the structure.

Figure 6: A portion of column C4 located under the stairs that have been repaired.

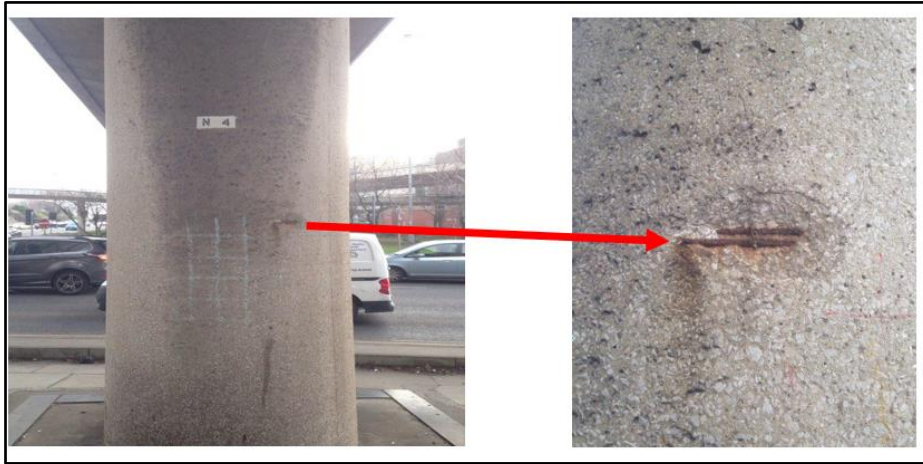
This test does not represent a correct analogue that the column N4 shown in Figure 7. From Churchill way flyover because the concrete flyover structure will not be as permeable as the concrete cube due to the mix design established for the structures primary use. Besides, the structure will be more exposed to road salt activities. Therefore, if dust were to be taken from the column N4, it would be easy to determine if chlorides were present. Due to the age of the structure, about 47 years old, chloride maybe has been included in the mix design. 'Calcium chloride was used as an accelerating admixture in concrete up until the mid-1970s' [23].

Figure 7: Exposed Reinforcement layer for column N4.

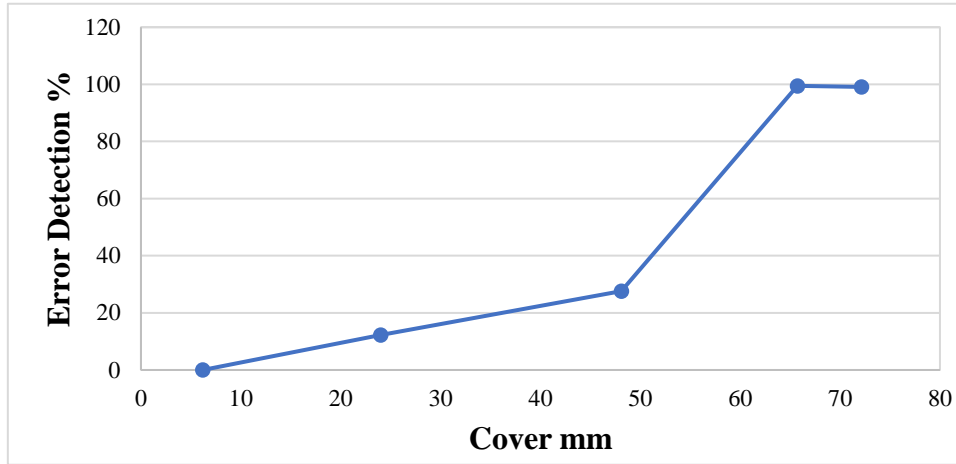
The graph in Figure 10 shows that any diameter recorded with a cover over 40mm, the results become less reliable. Even with the error that greater cover gives, however, you would likely be able to show the difference between main bars and the secondary reinforcements that both run vertically in a column, and the link bars that run horizontally. This supported by the fact that the vertical (main bars) are set behind link bars, as they have a greater cover.

Figure 10: Error in detecting rebar diameter with increasing cover depths [21].

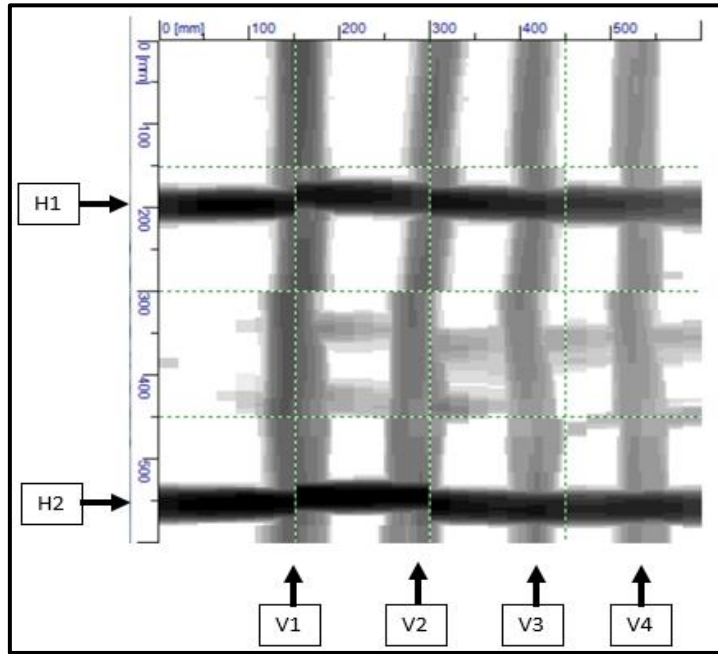
Table 8 and Figure 11 showed the results of a Ferro scan that been conducted on a concrete girder; these results only show the depth of cover and rebar diameter. Also, Figure 11 shows that there are some irregularities; this is reflected in Table 8 with one cover values being 98mm. These irregularities could be linked to the human error in this experiment, where the scanner may not roll across the correct section. As mentioned before the suggested class for this girder is XD3, this would mean a cover of 50mm according to EC2.

For the first horizontal bars shown in Table 8, the bar diameter ranging from 8-12 mm, and only one result shows that the bar diameter is 14mm. The 14mm bar diameter can be interpreted in two ways: the first one is the original bar diameter is H12, but this bar rusted and became larger. However, the second one is the original bar diameter is H16, and this bar has been corroded away to become smaller.

The results of cover for the vertical bars are ranging from 39-47 which is within class XD3 guidelines, and this is good as the most critical steel bars still have a minimum cover of 39mm which is still considered a good healthy protection layer. However, the bar diameter recorded are very different and ranging from 16-36mm. This difference in results can be interpreted in three ways: the first one demonstrated in Table 9, there are some results recorded at the Y-axis for horizontal bars around 340 and 420. These results might be the results of lapping bars where two ends of steel bars meet. When two metal bars are close to each other, it might cause an interaction to the magnetic field of these bars that could be disrupting the information the scanner receives. The second one can be attributed to pit corrosion that can reduce the diameter of the bar that the Ferro Scanner is possibly reading. The last one is, as almost all the vertical bars have a cover of 40mm or more, so the results recorded by the Ferro Scanner became less reliable as explained before depending upon Figure 11.

Figure 11: An image from the Ferro scanner created using the data from Table 8.

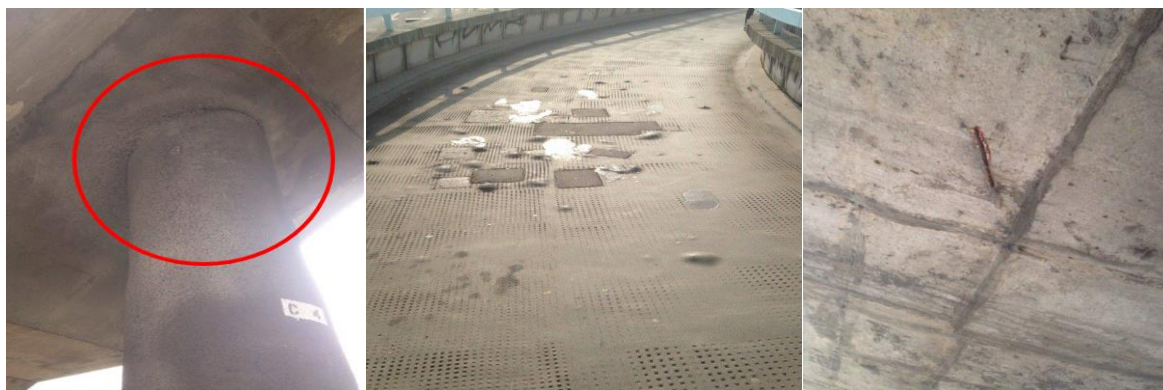
Although NDTs are comprehensive and they should be performed when carrying out any concrete structural inspection, however, a walk over to visually investigate the conditions of a structure, the loading on it and any addition or alterations is sometimes the most revealing aspect. A visual inspection of Churchill Way flyover was conducted on 14/02/2017. Visually it has been seen that the column supporting the stairs had been subject to repair works. This can be interpreted that the structure was undergone concrete attacks. Also, along the public walkway repair works have been conducted extensively, this could be attributed to the failing of water membrane, as shown in Figure 12. Besides, the public walkway, there are many places of exposed reinforcement layer; this can be attributed to de-passivation of concrete when its pH became around 9.

Figure 12: Defaults and cracks in Churchill Way flyover.

The NDTs that have been conducted have shown signs of corrosion and have indicated there may be issued with chlorides both externally from de-icing salts and internally from potential Mersey grit and calcium chloride. However, on every quantifiable level, the corrosion lies in controllable levels. Therefore, a recommendation would be to repair the structural visually now and save incurring further costs in the future because the aesthetics of the building are becoming a serviceability problem.

Finally, all the areas highlighted as high-risk need to be monitored and tested regularly, for example checking that the bar diameter size is still adequate or there will be a need for a more intrusive method of repair.
